Halligan Home Inspection LLC

Property Inspection Report

123 Sample Street, Myrtle Beach, SC 29575
Inspection prepared for: Mr. Sample & Mrs. Sample
Real Estate Agent: Super Agent - Super Real Estate Agency
Date of Inspection: 11/4/2013 Time: 11:00am Size: +/-1200sqft

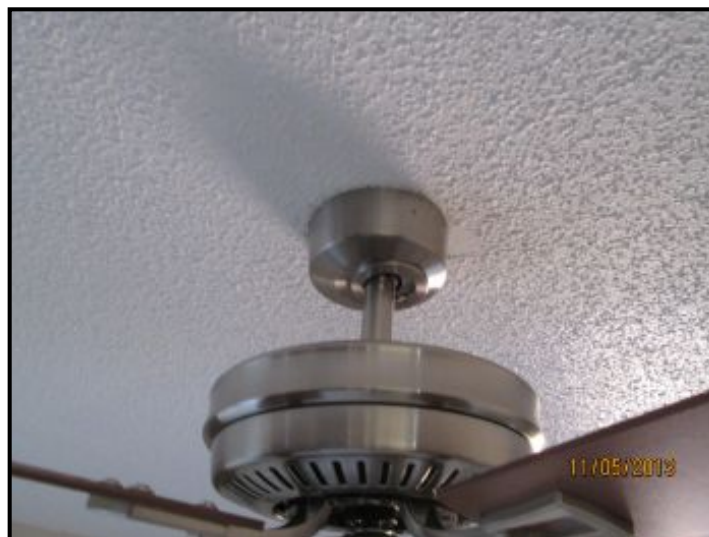
- The fan blades in dining area wobble when tested. Recommend balancing.

Needs Balancing

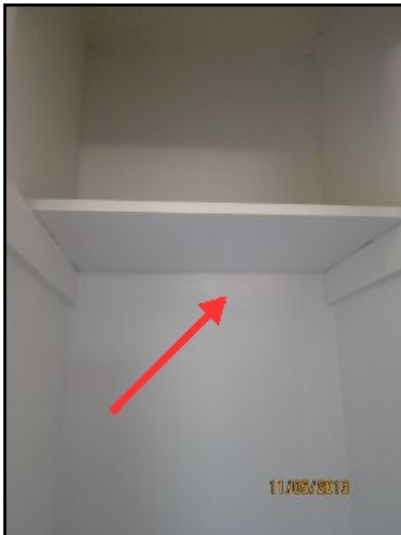
- Front Hall closet shelving and hanging bar is missing.

No Clothes Hanging bar

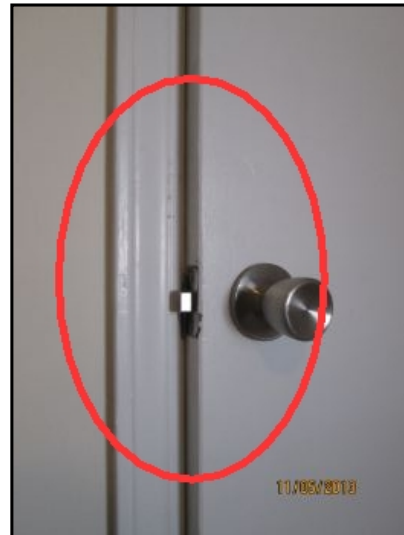
Doors do not close properly

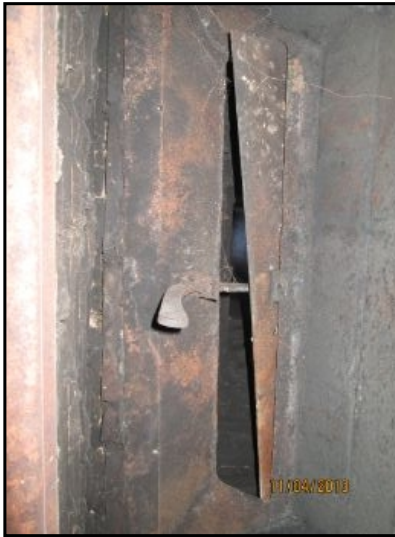
| Interior Areas | | |
|---|---|--|
| Page 6 Item: 11 | Fireplace | <ul style="list-style-type: none"> • The fireplace damper is damaged and not functional; The lever will not open or close the damper correctly. Do not attempt to start a fire until corrected. |

- The fireplace damper is damaged and not functional; The lever will not open or close the damper correctly. Do not attempt to start a fire until corrected.

The fireplace damper is damaged and not functional; The lever will not open or close the damper correctly. Do not attempt to start a fire until corrected.

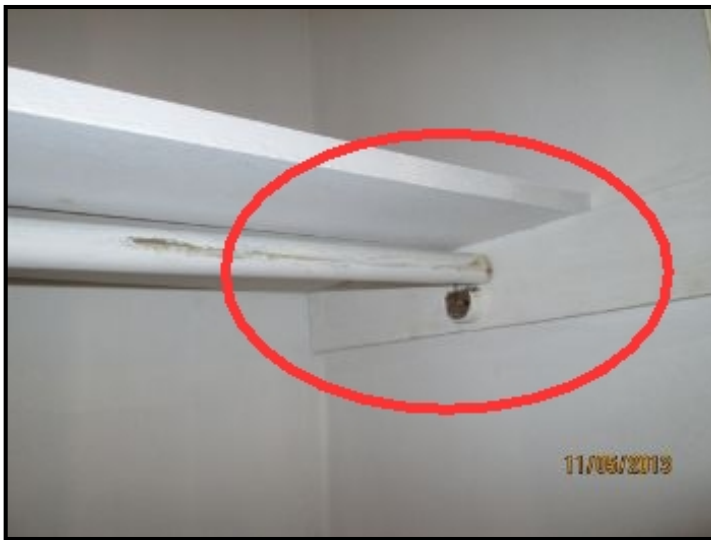
- The closet is in serviceable condition. Master closet has improper installation of clothes hanging bar.
- Front hall closet missing hanging bar.

Master Bedroom Closet Clothes Hanging bar improperly installed

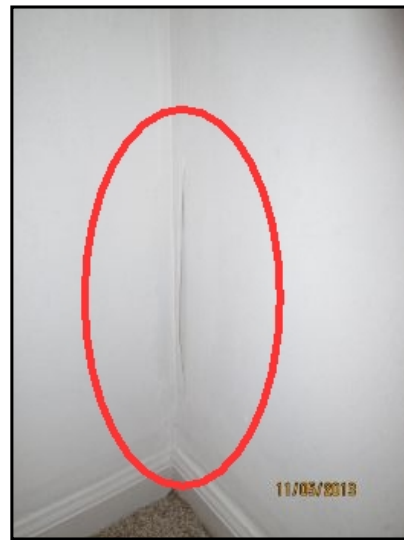
Master Bedroom closet Drywall Tape separation

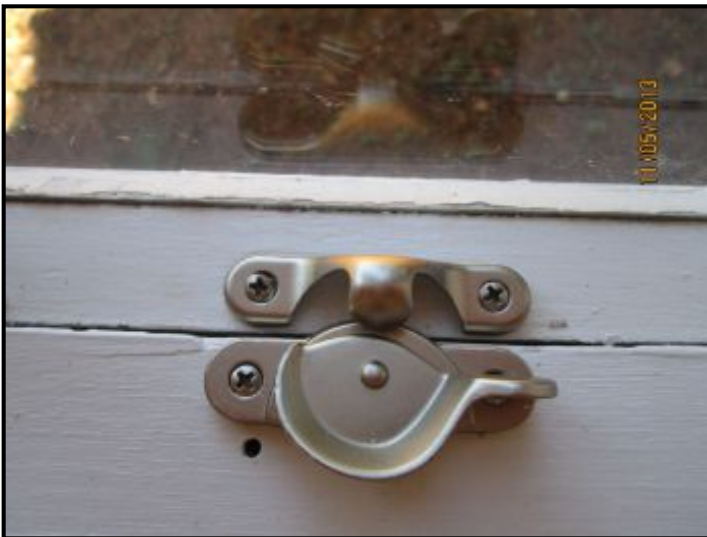
- One or more windows did not lock/latch properly, recommend repairs for enhanced security/safety to occupants.
 - Single pane windows observed, recommend budgeting for replacement for added efficiency of home.
 - Painted wood windows possibly creating lead dust from friction on paint. Due to fresh paint, windows difficult to operate.
 - Screens were not installed at time of inspection.
 - The windows that were tested, are functional.
 - Locking mechanism hardware broken and needs repair/replacement in Master Bedroom.
- Locking mechanism requires relocation in order to operate (open/close) properly in Bedroom #2.

Bedroom #2 Window Hardware needs to be relocated in order for window to be operational

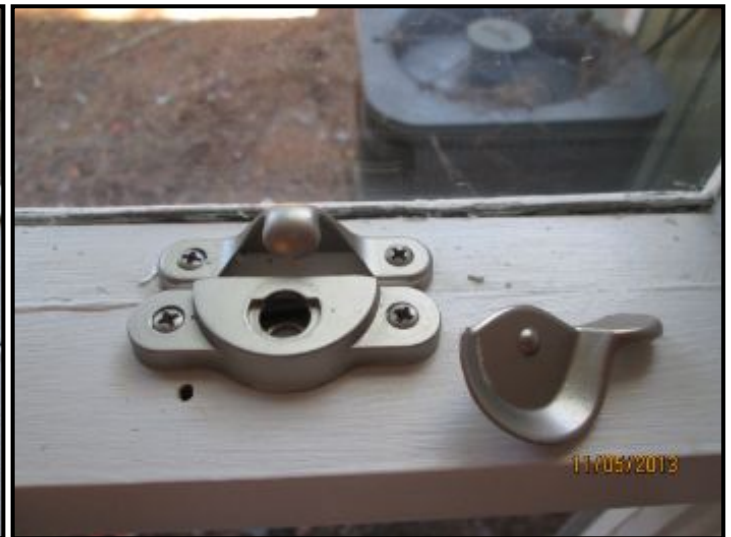
Master Bedroom Window Hardware broken

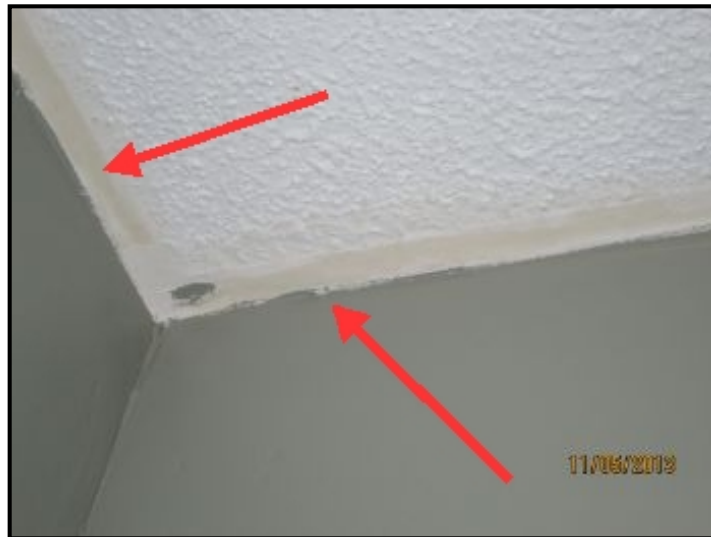
- Freshly painted in areas. This could be concealing a defect that could not be determined. Small amount of painters tape noted in Hall bath.
- Wood ceiling in Master Bath subject to moisture exposure due to improper ventilation and proximity to water source (shower) itself. Recommended that ceiling be properly treated and sealed to maintain integrity and longevity.

Painters Tape

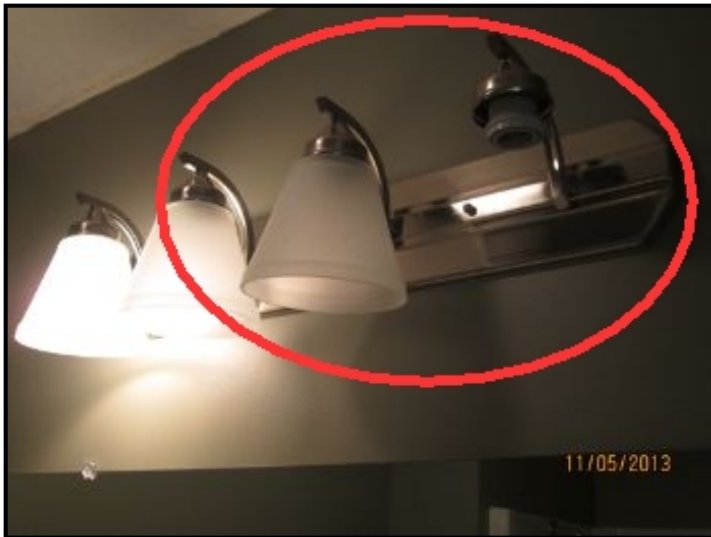
- Light fixture or bulb apparently inoperable at Master Bath vanity. Change bulb(s) and check. Hall bath missing Globe and light bulbs.
- **GFCI trip test failed. Have licensed electrician evaluate and repair / replace as necessary. Hall bath has no GFI present.**

Hall Bath Missing Globe and light bulbs

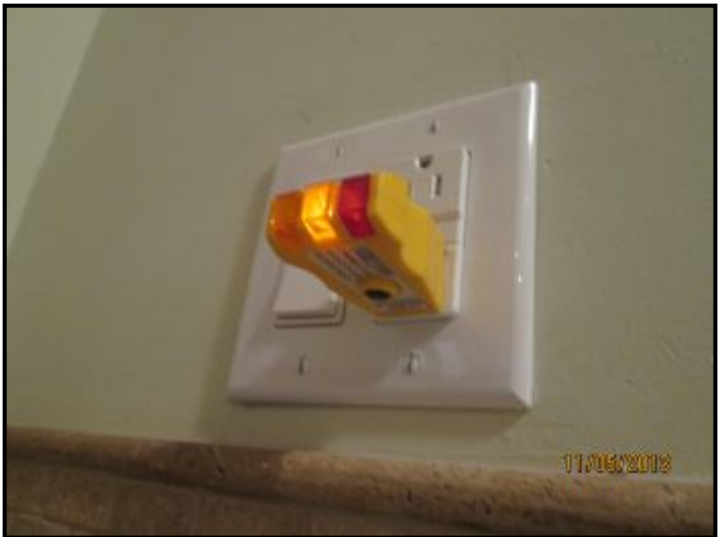
| Interior Areas | | |
|---|---|--|
| Page 9 Item: 6 | Electrical | <ul style="list-style-type: none"> • GFCI trip test failed. Have licensed electrician evaluate and repair / replace as necessary. Hall bath has no GFI present. |

Master Bathroom Upside Down GFCI showing Open Ground (Bottom)

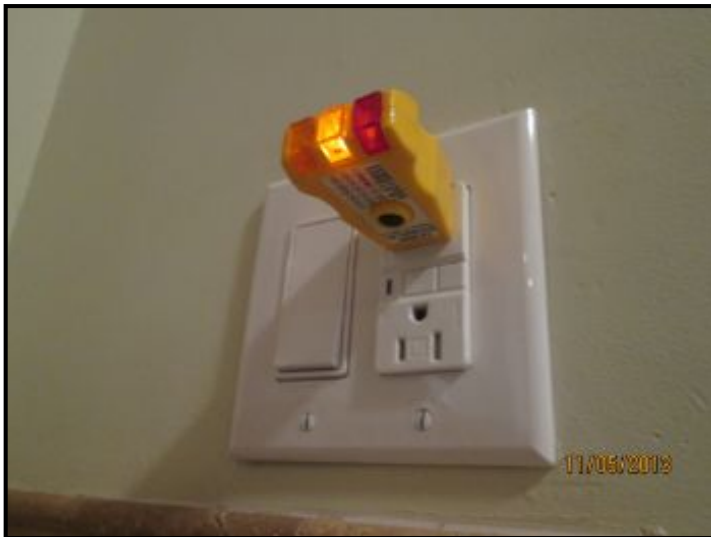
Master Bathroom Upside Down GFCI showing Open Ground (Top)

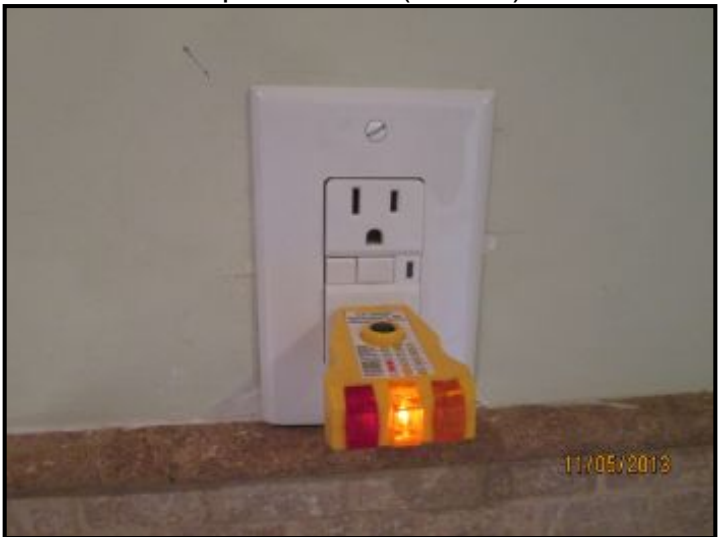
Master Bedroom Opposite GFCI also showing Open Ground

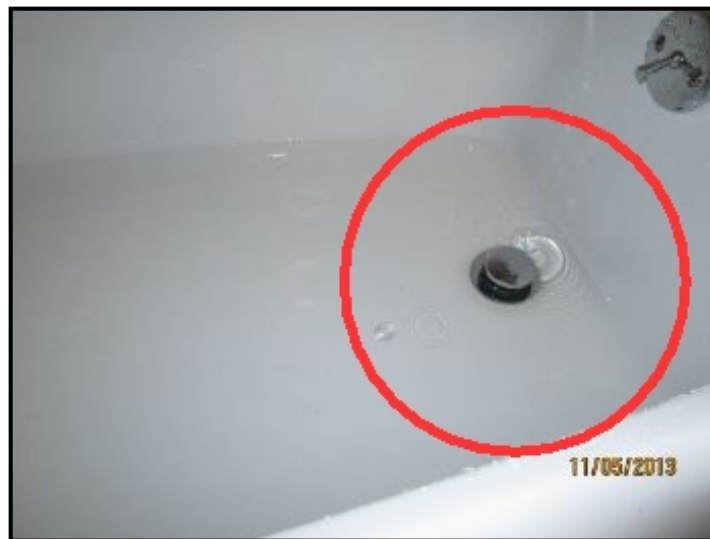
- Hall bath has very poor Pressure at sink and shower head locations.
- **** Master Bath**** The hot & cold water supplies are reversed. This is not a functional problem but to someone who is not familiar with this condition unexpected hot water could scald them. We suggest contacting a qualified plumbing contractor to repair.
- Hall bath/tub drain not operating correctly. Drain appears to be clogged and not draining properly while drain is in the OPEN position. Additionally, when drain is in the CLOSED position, drain stopper still drains water. This drain is not working properly. Recommended to have a certified plumber evaluate and correct as necessary.

Hall Bath. Drain OPEN but still holding water

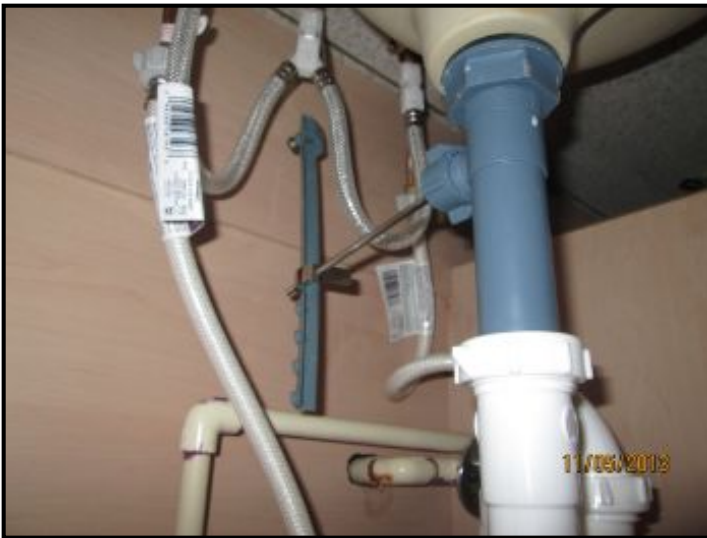
- Stopper is missing/inoperable. Both sinks in Master Bedroom.

Stopper is missing/inoperable. Both sinks in Master Bedroom. Left sink

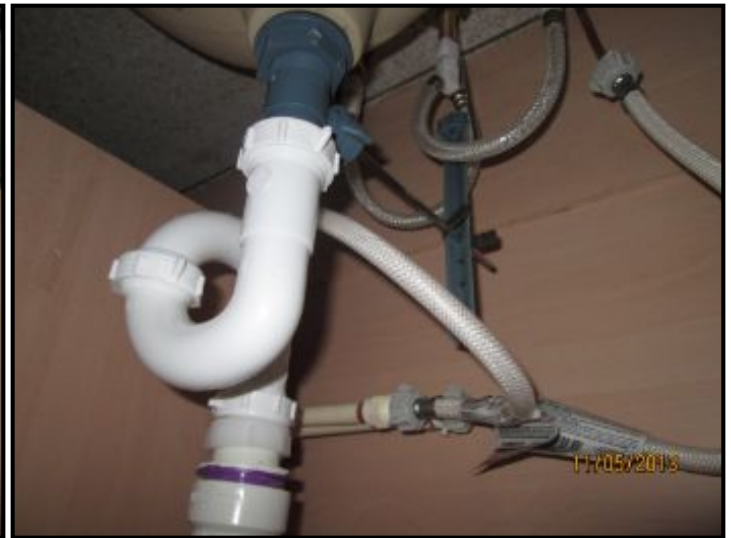
Stopper is missing/inoperable. Both sinks in Master Bedroom. Right sink

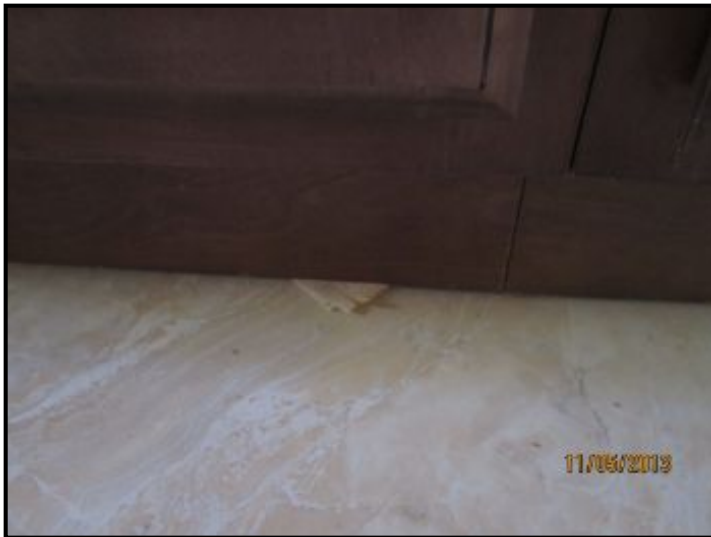
- Other than missing filler/spacer pieces and a small cabinet appearing to be a different shade than the others, Appeared functional and in satisfactory condition, at time of inspection.

Shim

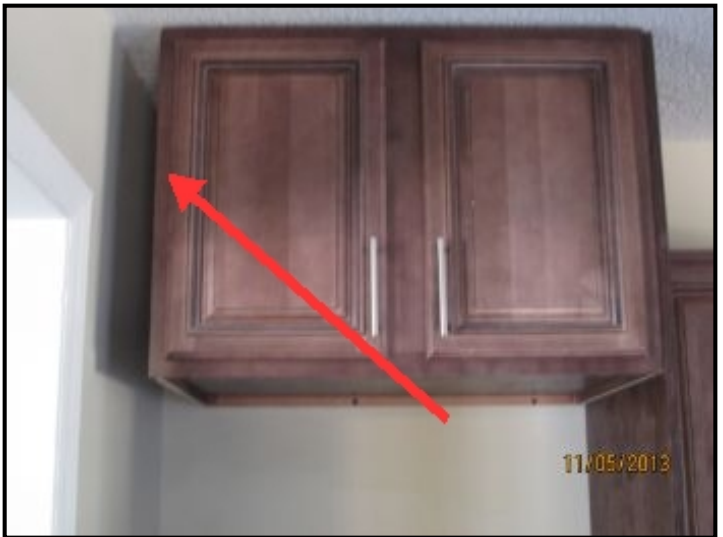
Filler/Spacer missing

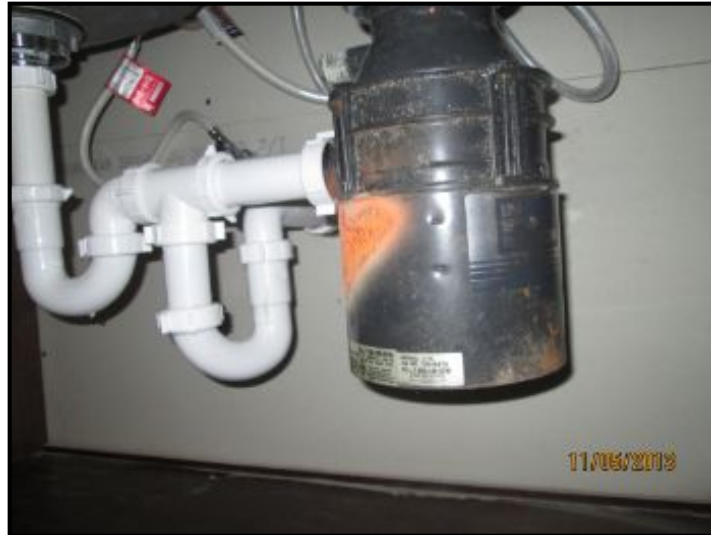
- Other than limited Hot Water during time of inspection and no dishwasher plumbing installation provided, all plumbing appeared to be appropriately functional.

No Dishwasher connection

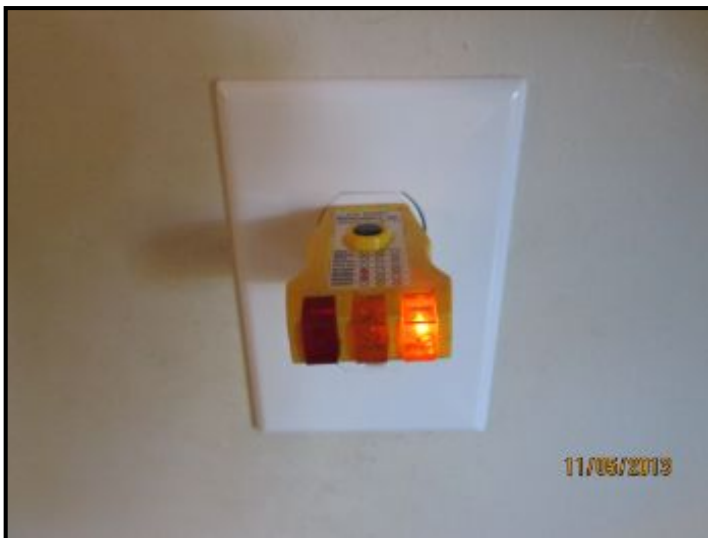
| Interior Areas | | |
|---|---|--|
| Page 14 Item: 10 | Electrical | <ul style="list-style-type: none"> • GFCI trip test failed. Have licensed electrician evaluate and repair / replace as necessary. |

Open neutral in Kitchen

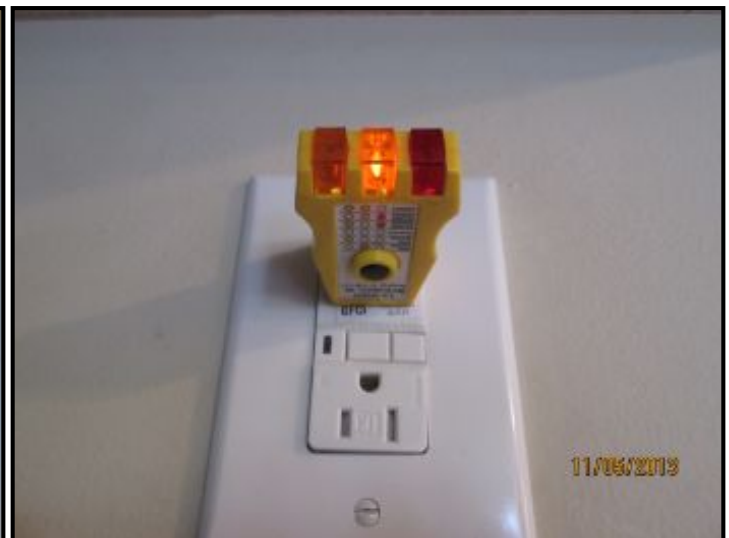
Upside down GFCI and Open ground

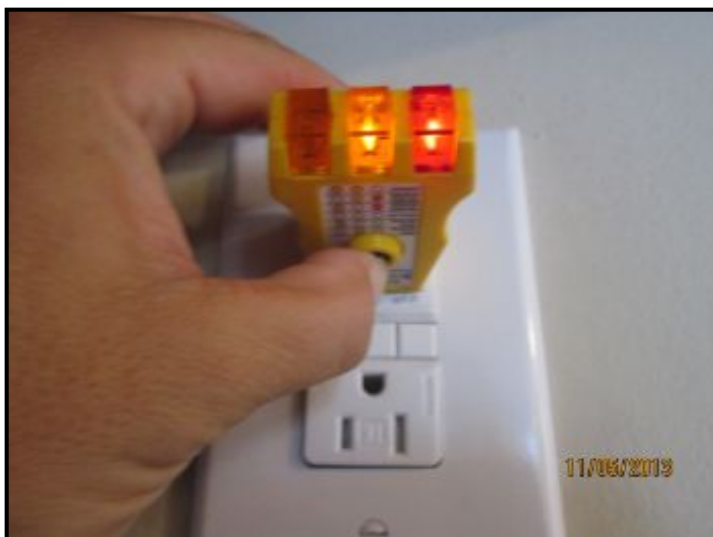
Upside down GFCI and Hot/Neutral Reverse

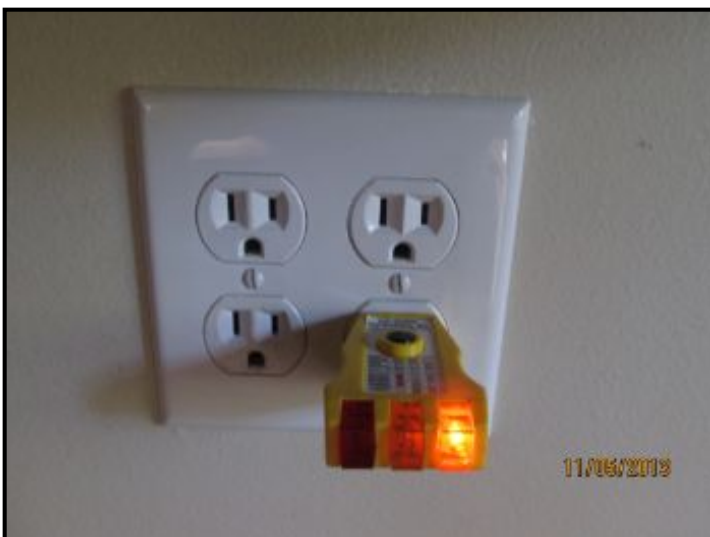
Open Neutral

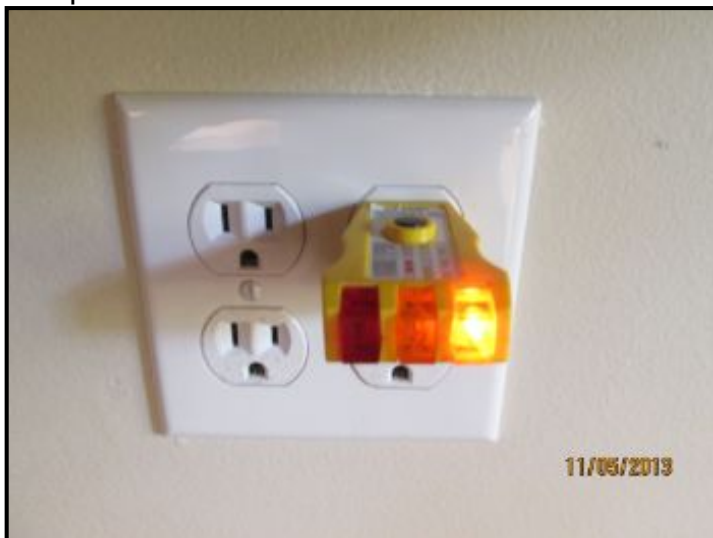
Open Neutral

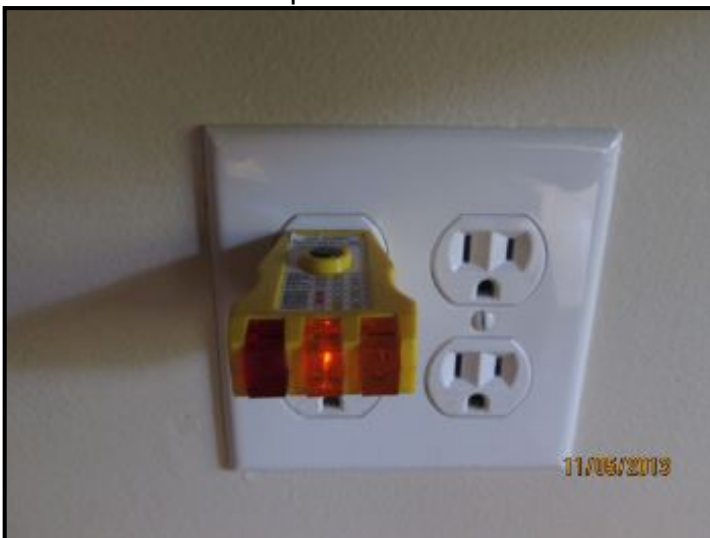
Open Ground

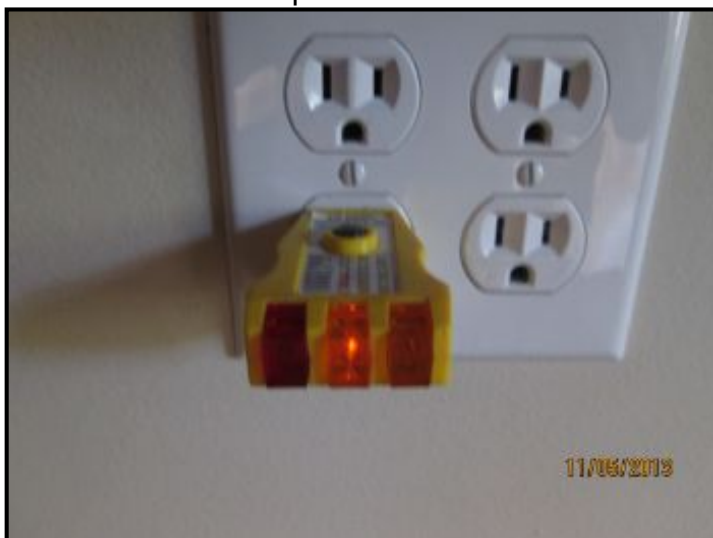
Open Ground

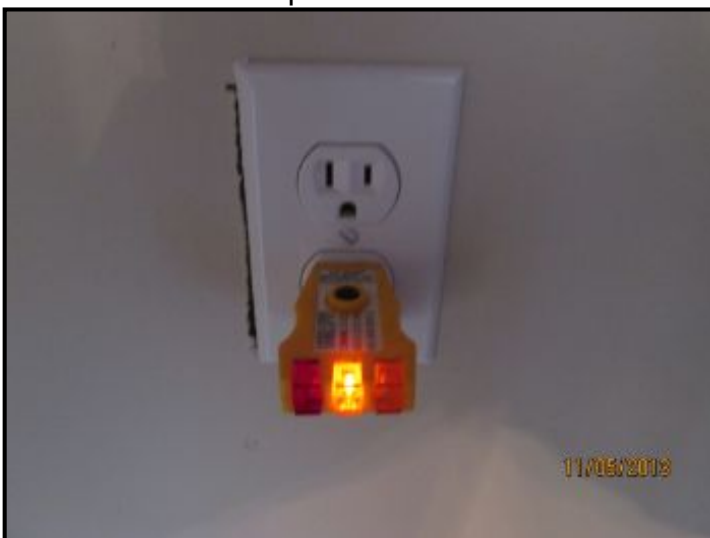
Open Ground

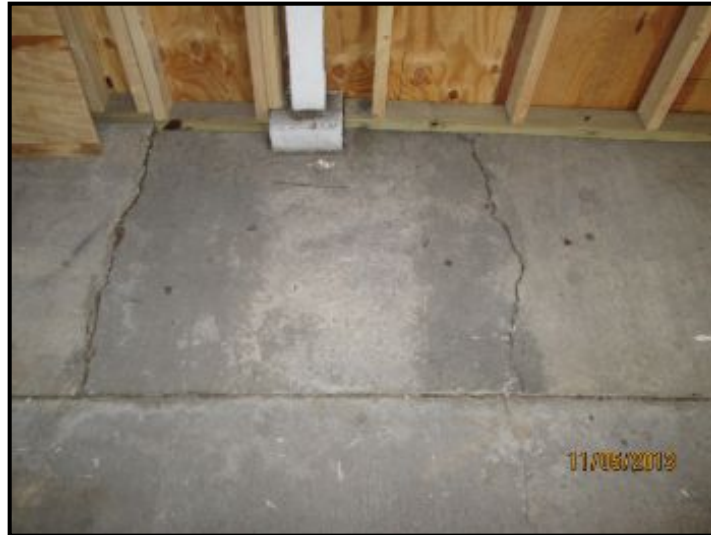
- Common cracks noted.

Common cracks noted.

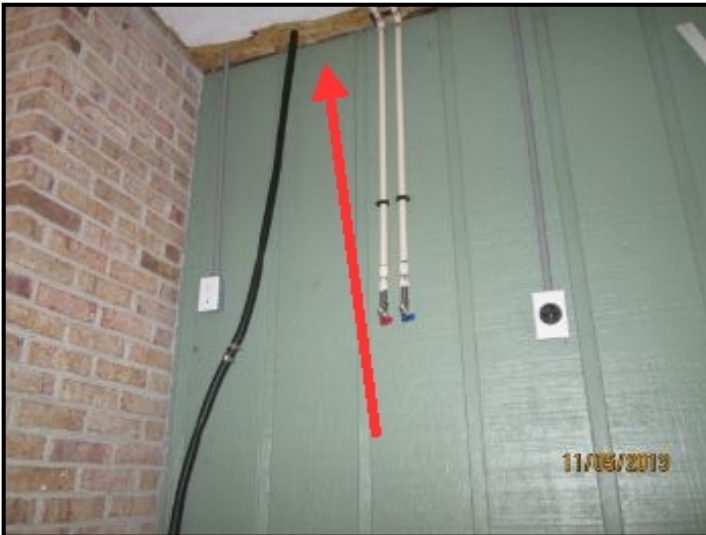
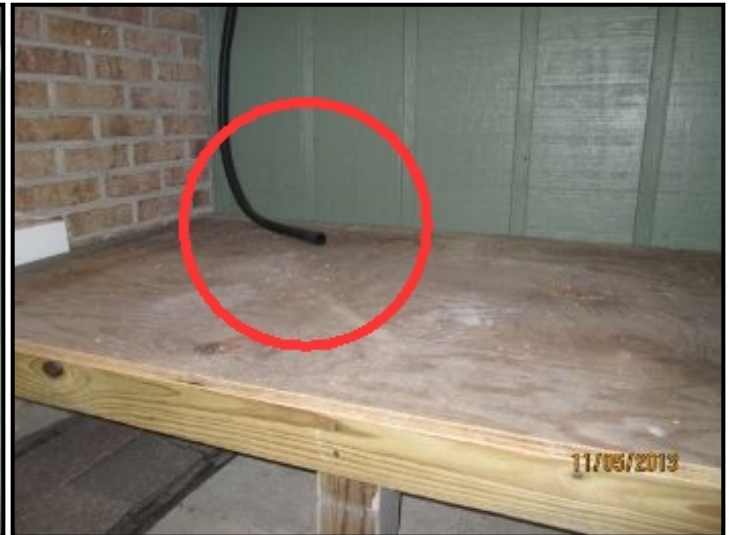
| Page 17 Item: 5 | Plumbing | <ul style="list-style-type: none"> • Unconventional installation of Washing Machine drain. Appears to go up into the attic and run along the length of the home inside the attic. Due to no appliance in the home at the time of the inspection, no way to properly test drainage system. Recommend a certified plumbing contractor evaluate and correct drainage system if required. |

- Unconventional installation of Washing Machine drain. Appears to go up into the attic and run along the length of the home inside the attic. Due to no appliance in the home at the time of the inspection, no way to properly test drainage system. Recommend a certified plumbing contractor evaluate and correct drainage system if required.

Unconventional installation of Washing Machine drain. Appears to go up into the attic and run along the length of the home inside the attic. Due to no appliance in the home at the time of the inspection, no way to properly test drainage system. Recommend a certified plumbing contractor evaluate and correct drainage system if required.

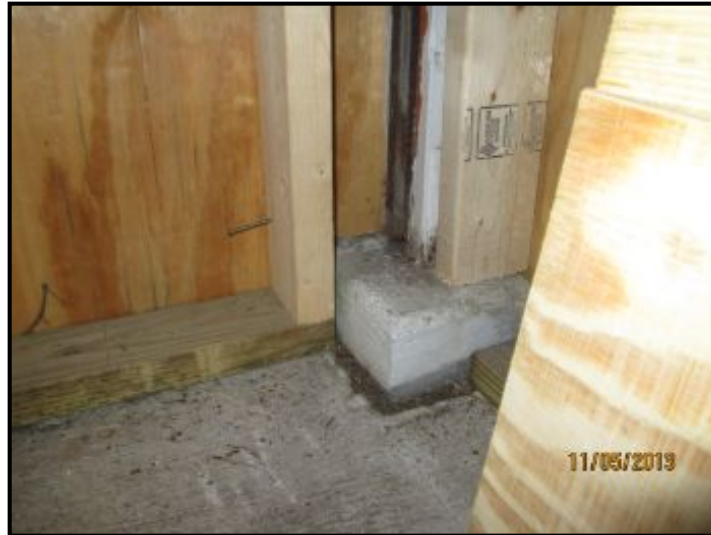
- Missing drywall noted.

Missing drywall noted.

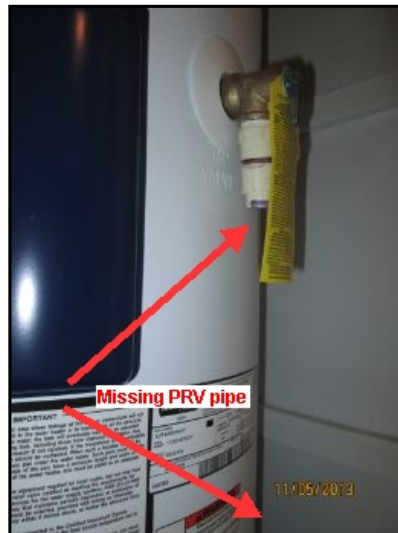
| Page 21 Item: 3 | Water Heater Condition | <ul style="list-style-type: none"> • The extension at the water heater relief valve is missing. This is a potential scalding concern as water can discharge improperly. Recommend installing the proper type of relief extension to discharge within 6" from the floor. • During 30-45 minute water testing period Hot water was extremely limited in ALL area's of the home. It is recommended to have a licensed Plumbing contractor review the current installation and sign off on the proper operation of How Water system entirely. |
| Page 21 Item: 4 | TPRV | <ul style="list-style-type: none"> • The TPR valve discharge tube ** which was not presently installed** must be made of copper, iron, or CPVC (NOT regular PVC). It must terminate within 6" above the floor--the end cannot be threaded or have a fitting. Recommend a licensed Plumbing contractor install prior to occupancy. |

The extension at the water heater relief valve is missing. This is a potential scalding concern as water can discharge improperly. Recommend installing the proper type of relief extension to discharge within 6" from the floor.

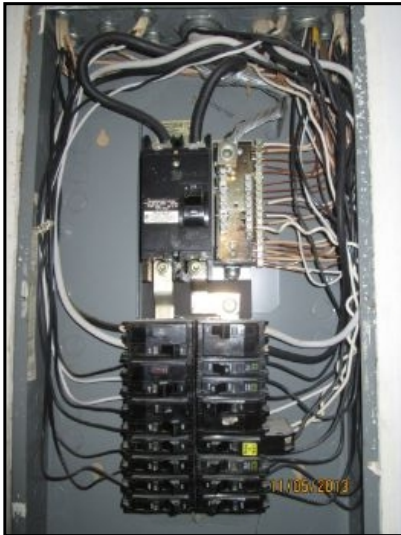
- Panel cover screw(s) missing.

Service Panel

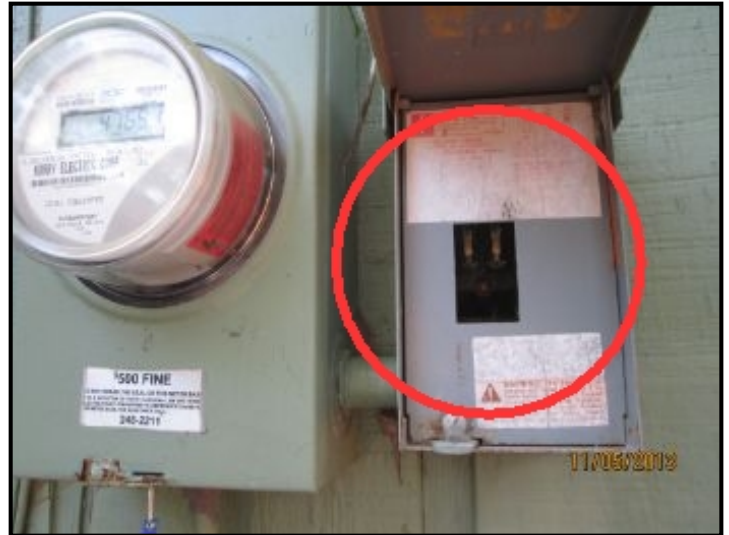
Exterior Breaker box has NO BREAKERS

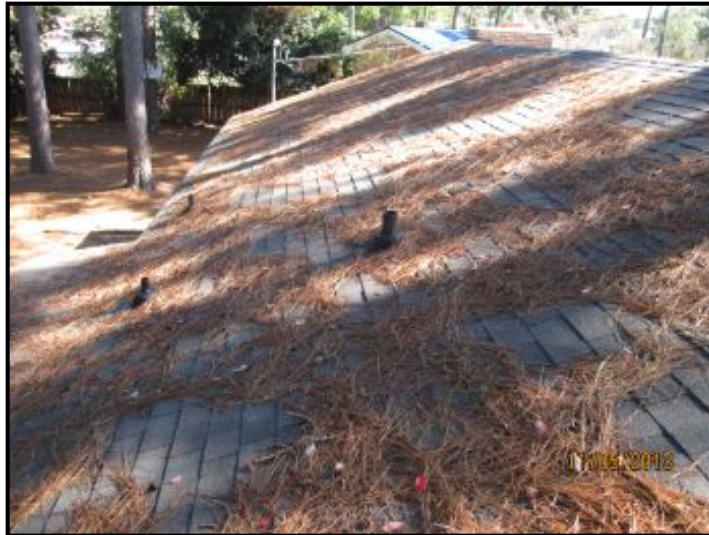
| Page 22 Item: 1 | Roof Condition | <ul style="list-style-type: none"> • Clean roof areas: Significant amounts of organic debris evident. • Roof ventilation may be inadequate; this may contribute to premature roof failure, conducive conditions for mold growth in attic, and/or high heating / cooling bills. Consider further evaluation by qualified contractor. |

Clean roof areas: Significant amounts of organic debris evident.

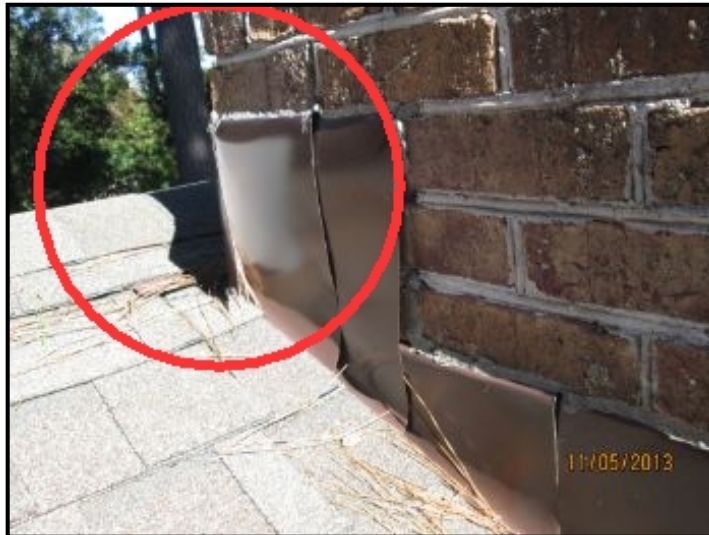
| Page 25 Item: 2 | Flashing | <ul style="list-style-type: none"> • Typical maintenance necessary, now and on an annual or semi-annual basis. This generally consists of resealing gaps at through-the-roof projections and at the parapet walls as necessary. • Small portion of the Flashing appears installed improperly; see photo. Recommend repair. |

Small portion of the Flashing appears installed improperly; see photo. Recommend repair.

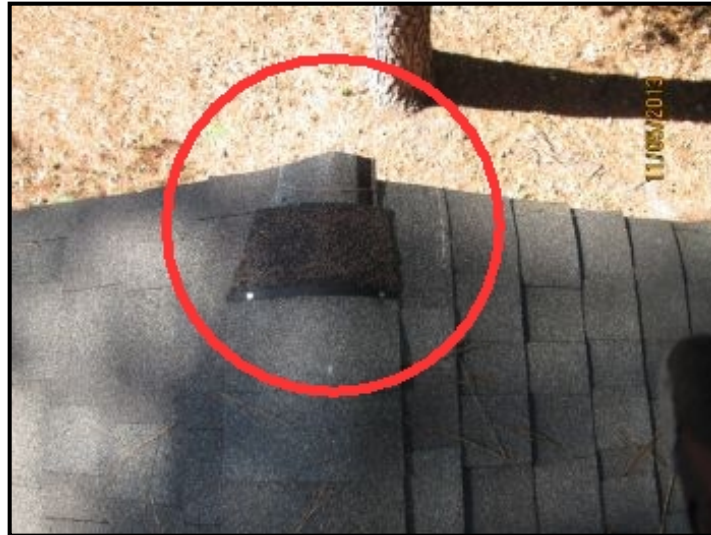
Shingle missing on ridge

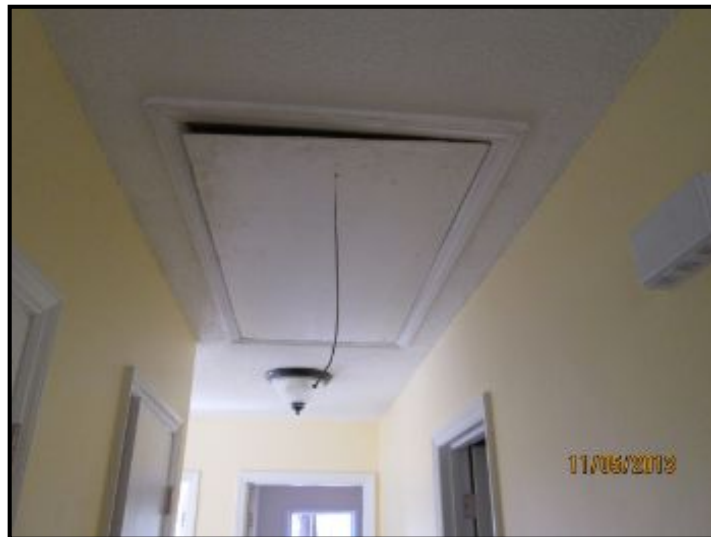
Access Hatch not flush to ceiling

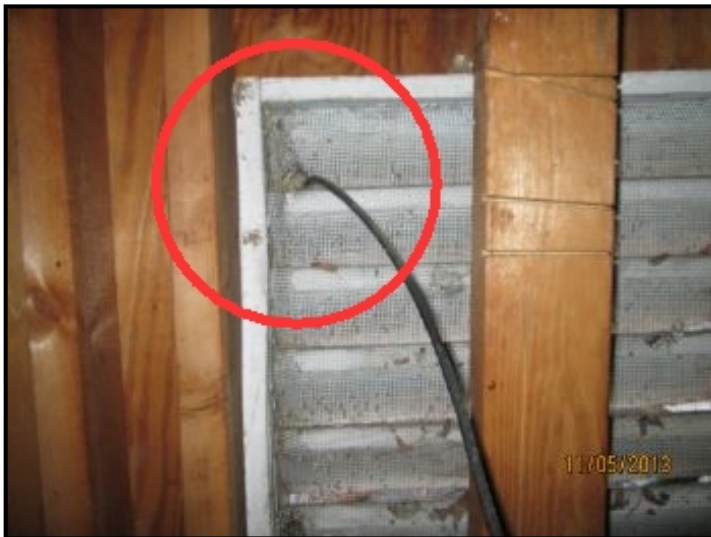
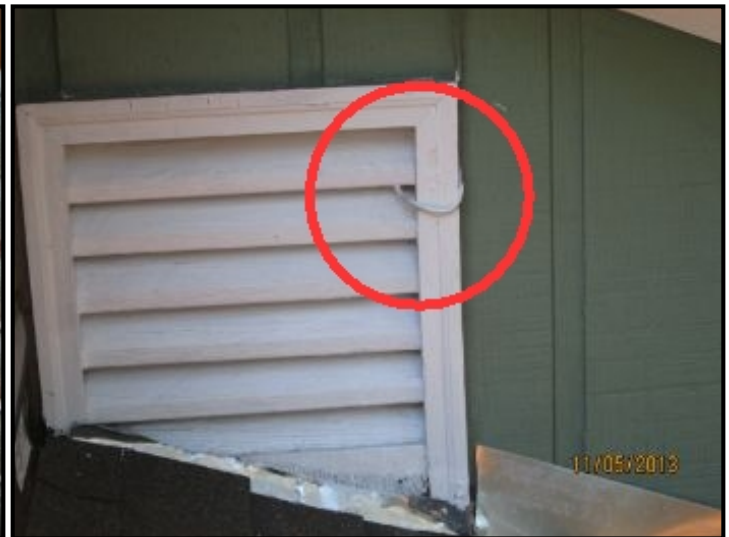
- Vent screens noted as functional. Although Coaxial cable noted to be pushed through South side vent.

Vent screens noted as functional. Although Coaxial cable noted to be pushed through South side vent.

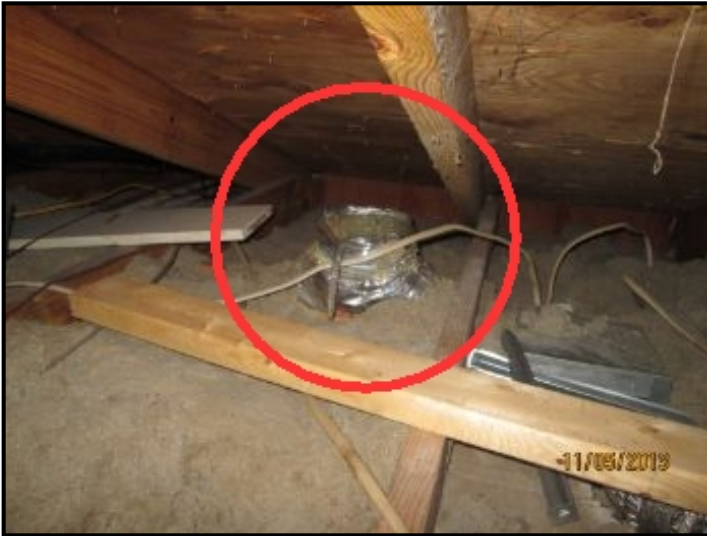
Open Duct

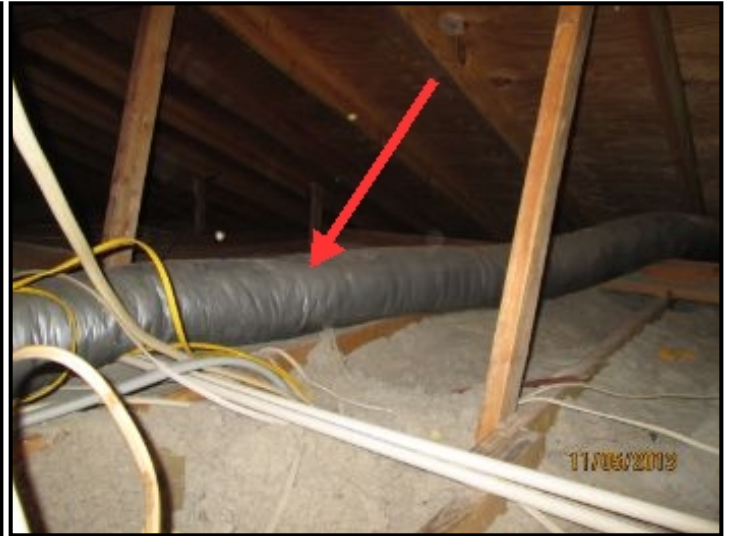
- Possible asbestos materials observed. The materials appeared to be in serviceable condition at the time of inspection. Asbestos materials are considered safe by the EPA if they are not disturbed, torn, ripped, or damaged. No torn, ripped, or damaged materials were observed. If client has any concerns regarding asbestos materials, an asbestos testing lab should be consulted for further review to ensure safety.
- Functional.
- See HVAC page.

Possible asbestos materials observed. The materials appeared to be in serviceable condition at the time of inspection. Asbestos materials are considered safe by the EPA if they are not disturbed, torn, ripped, or damaged. No torn, ripped, or damaged materials were observed. If client has any concerns regarding asbestos materials, an asbestos testing lab should be consulted for further review to ensure safety.

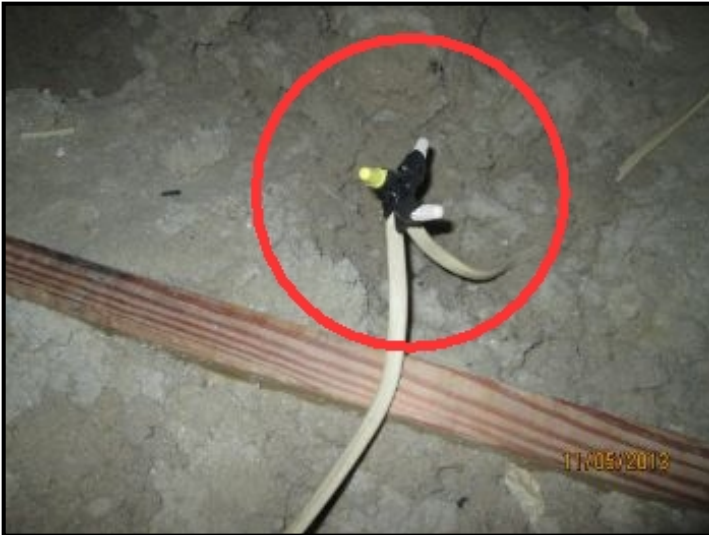
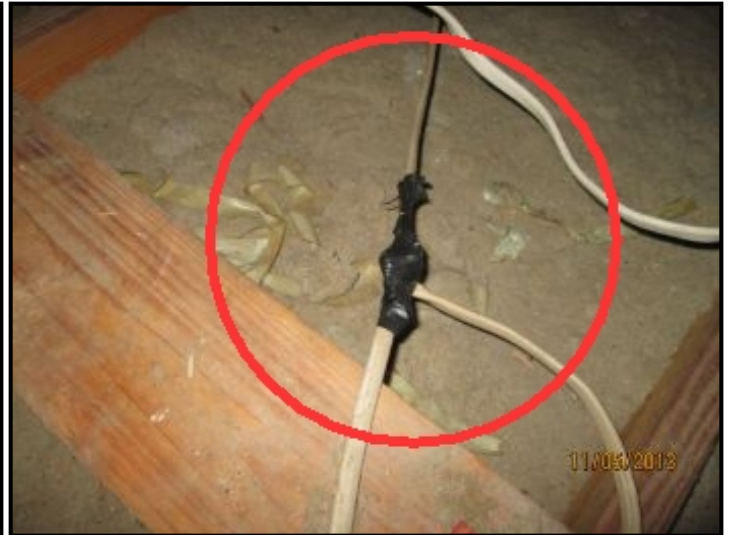
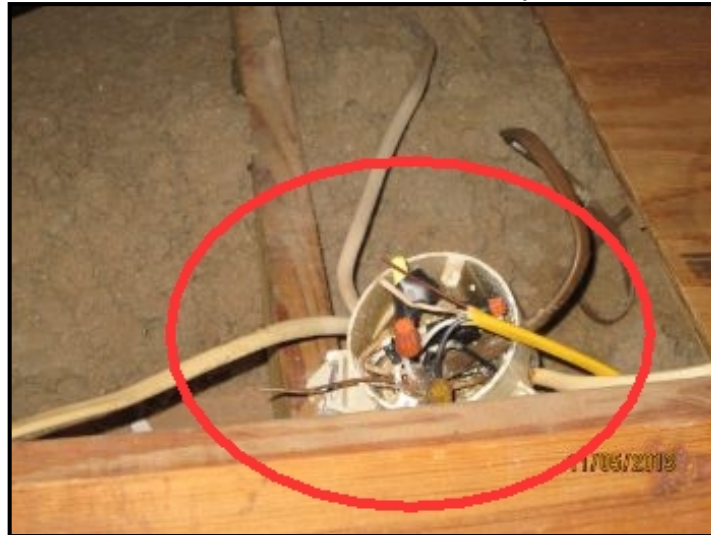
| Page 28 Item: 6 | Electrical | <ul style="list-style-type: none">• Connections made outside of a Junction Box, which is a potential shock or electrocution hazard.• Wire ends are outside of a Junction Box, which is a potential shock or electrocution hazard. |

- Connections made outside of a Junction Box, which is a potential shock or electrocution hazard.
- Wire ends are outside of a Junction Box, which is a potential shock or electrocution hazard.

Wire ends are outside of a Junction Box, which is a potential shock or electrocution hazard.

Connections made outside of a Junction Box, which is a potential shock or electrocution hazard.

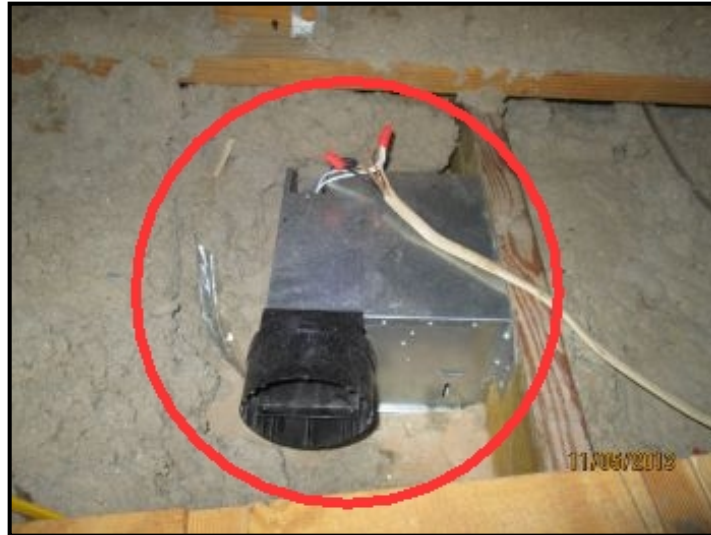
| Page 30 Item: 9 | Exhaust Vent | <ul style="list-style-type: none">• Bathroom Fan's were being ventilated directly into attic area. This may cause moisture in the future. Recommend proper ventilation to the exterior via vent piping through roof. |

- Does not extend to exterior air.
- Missing vent pipe.
- Bathroom Fan's were being ventilated directly into attic area. This may cause moisture in the future. Recommend proper ventilation to the exterior via vent piping through roof.

Bathroom Fan's were being ventilated directly into attic area. This may cause moisture in the future. Recommend proper ventilation to the exterior via vent piping through roof.

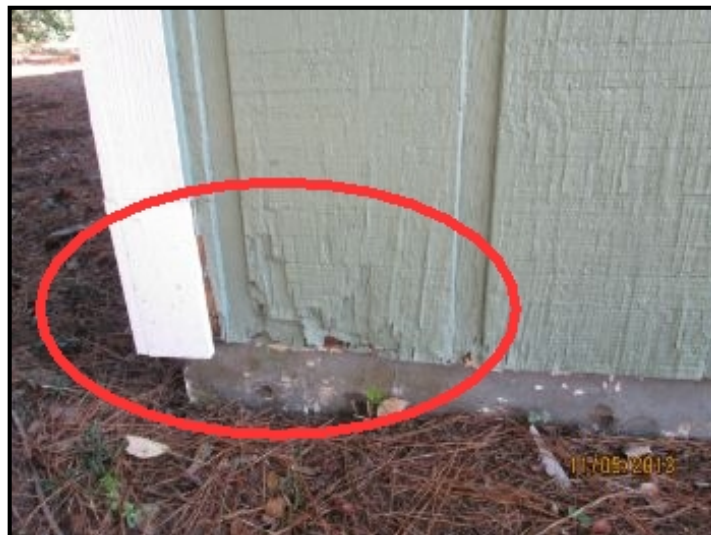
- Fresh paint was observed. Although it improves the appearance, it may conceal any possible defects or prior repairs.

Visible deterioration of siding. Freshly painted

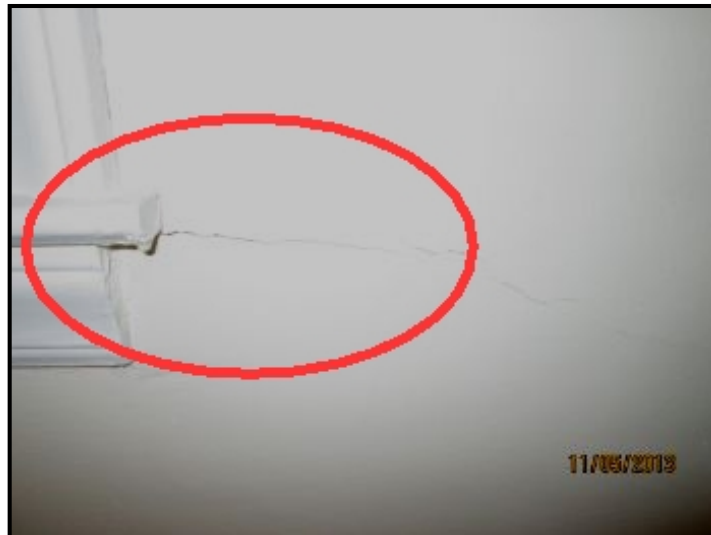
Settlement crack at Master Bedroom window

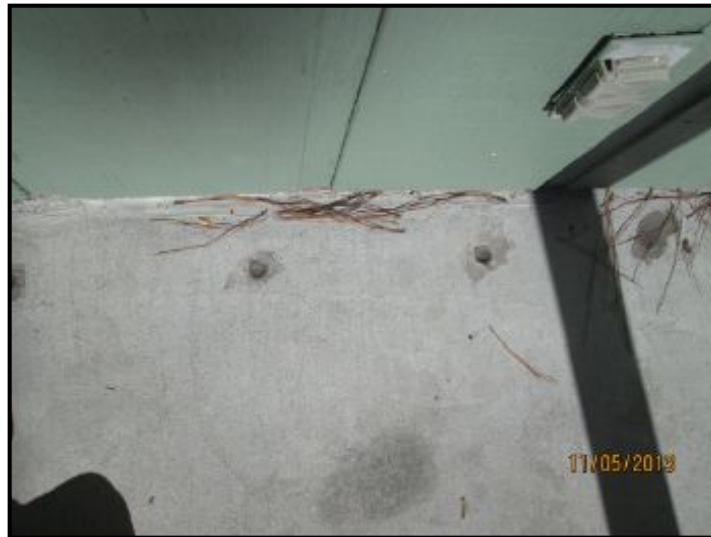
- Normal settlement.
- Other than visible Pest Infestation Treatment holes noted along perimeter of foundation walls, No deficiencies were observed at the visible portions of the structural components of the home.

Other than visible Pest Infestation Treatment holes noted along perimeter of foundation walls, No deficiencies were observed at the visible portions of the structural components of the home.
